# Fort Detrick, Maryland

## Crash Location Enhancement Study

**June 2000**

**Gannett Fleming**

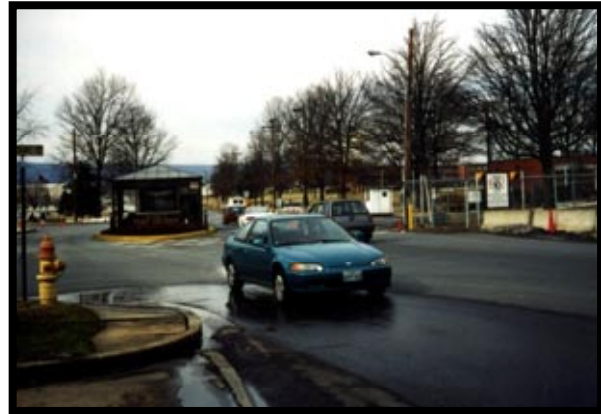
Figure 2. Intersection of Military Road, 7<sup>th</sup> Street and Ditto Avenue (Main Gate – northward view).

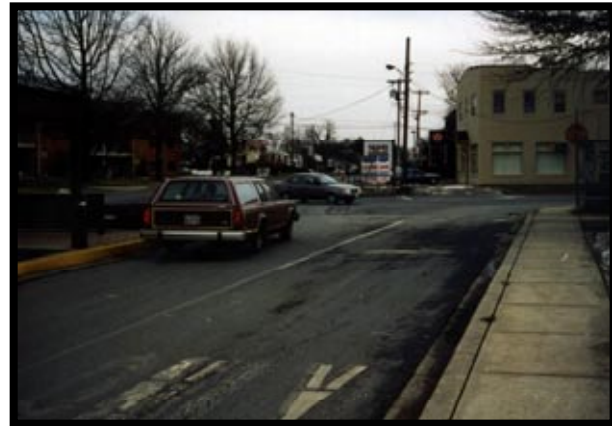
- **Roadside Hazards:** None.
- **Sight-distance Restrictions:** Business and advertisement sign in the southwest corner of the intersection restricts sight distance for vehicles attempting to enter the intersection from Military Road and Ditto Avenue.

Figure 3. Sight distance restriction at Military Road, 7<sup>th</sup> Street and Ditto Avenue (southward view)

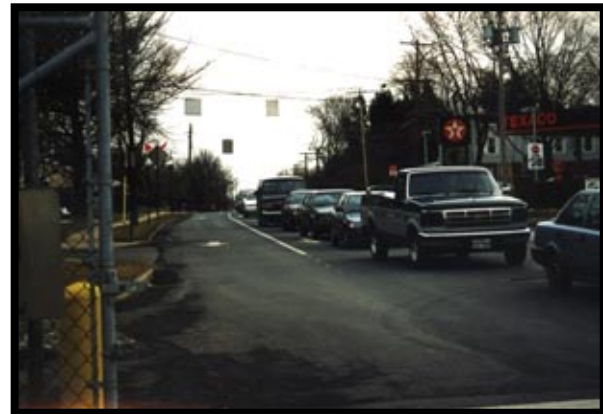
**Figure 5. Queue from Main Gate stacking into the intersection during AM Peak (southward view).**

The second factor involves the location of the gate. To the south, there is approximately 60 feet of storage per each of the two lanes between the gate and the intersection. This limited capacity to store vehicles waiting to be processed often causes vehicles to back into the intersection during the peak traffic periods. There is also only approximately 200 feet of storage between this intersection and the intersection with Porter Street along Ditto Avenue for vehicles exiting the installation. During PM peak hour data collection, queuing occurred through the Ditto/Porter intersection and along each of these roadways.

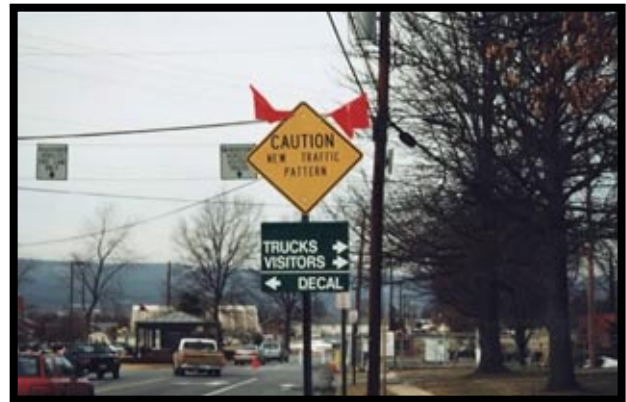
The lane use approach signing along 7<sup>th</sup> Street is poor due to the size, color, and font of the lettering. The signing is critical to the operation of the gate and intersection. Figure 7 is a concept plan for signing the 7<sup>th</sup> Street approach to the installation.

**Figure 6. Existing 7<sup>th</sup> Street approach signing (northward view).**

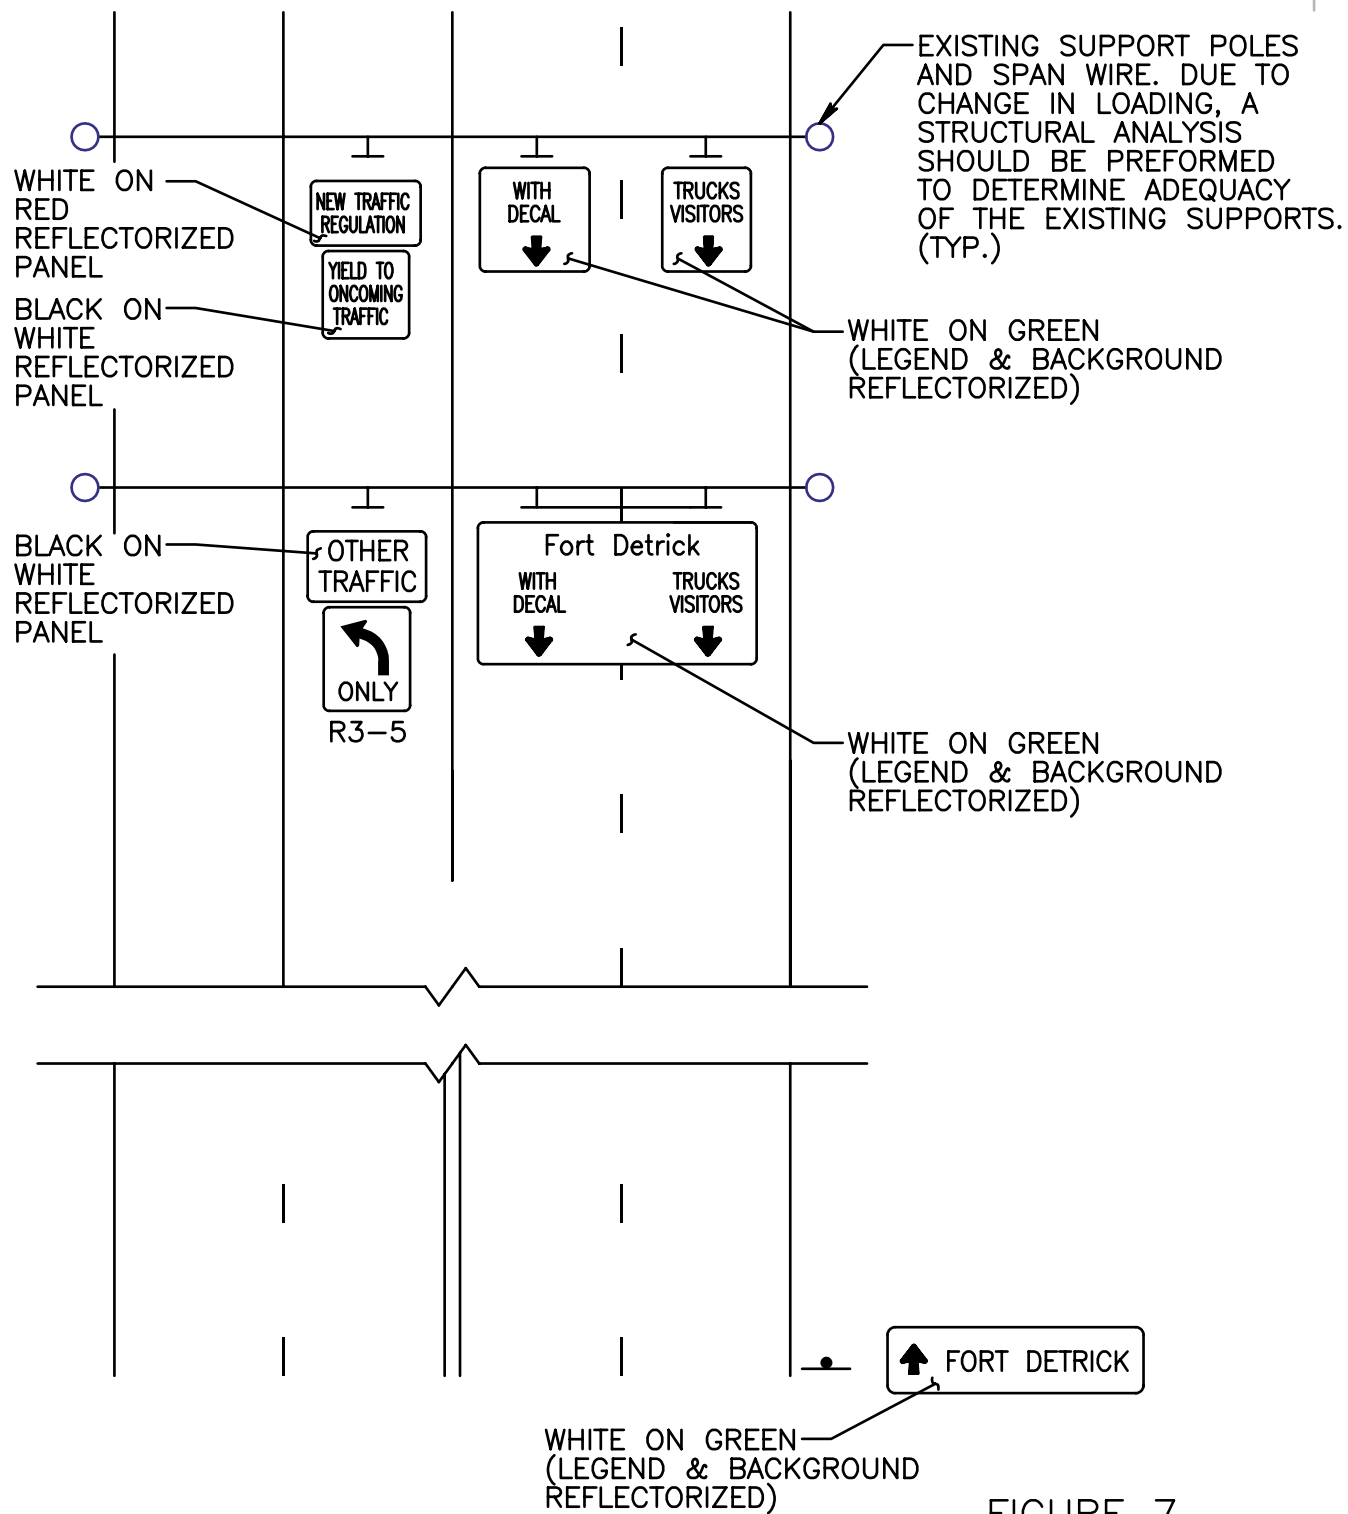
FIGURE 7

PROPOSED 7th STREET  
APPROACH SIGNING

- Revise advanced signing on 7<sup>th</sup> Street and Military Road as per Figure 7. The estimated cost of this improvement is \$8,000.
- Revise the gate operation to two sentry stations:
  1. The large, existing sentry station in the median island to monitor and wave motorists with decals through the intersection. Vehicles with decals will continue to use the inside lane.
  2. Remove the existing island along Northbound Ditto Avenue and construct a new island with a sentry station for easy access to the driver's side of visiting truck

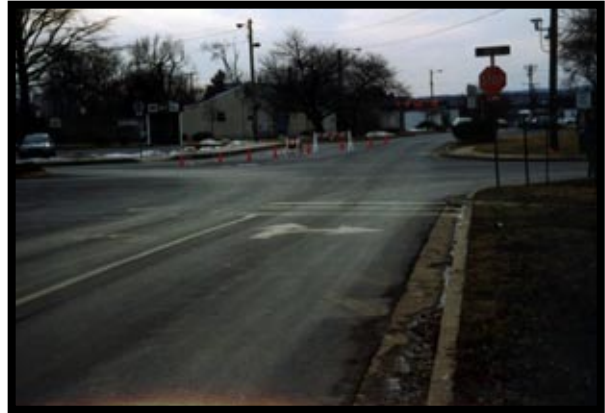
Figure 9. Intersection of Ditto Avenue and Porter Street (westward view).

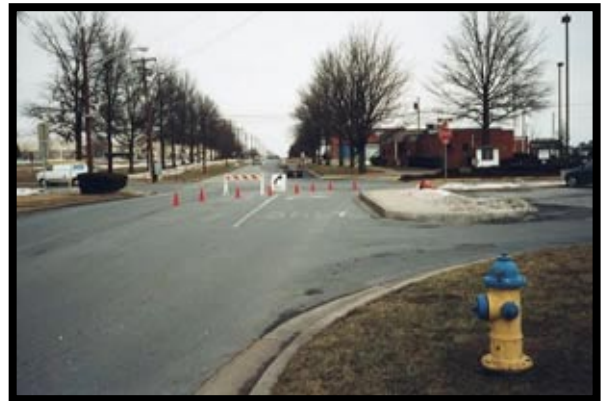
Figure 10. Temporary channelization of eastbound vehicles on Ditto Avenue at Porter Street.

- Install permanent concrete channelizing island on the eastbound approach. Estimated cost for this improvement is \$3,400.
- ADA ramps should be added at the northern crosswalk on the northeast corner of the intersection. Estimated cost for this improvement is \$1,000.
- Install R9-3a “No Pedestrian Crossing” signs to the south side of the intersection. The estimated cost of this improvement is \$300.
- Replace stop signs and 3-way placards on all approaches. The estimated cost of this improvement is \$1,000.
- Replace worn pavement markings on all approaches to the intersection. The markings include word markings, symbol markings, stop bars, lane lines, and centerlines. The materials and application of the markings should meet state or local specifications to ensure proper reflectivity and durability. The estimated cost of this improvement is \$1,000.

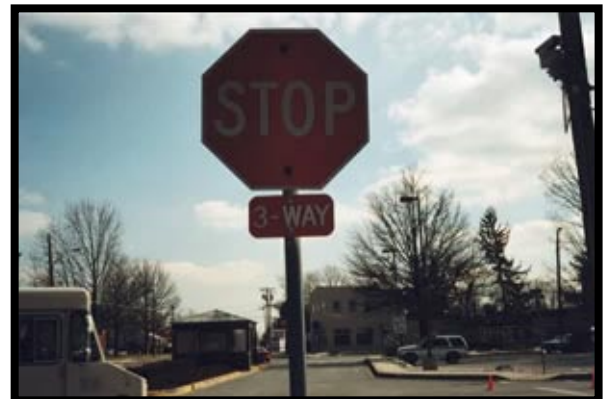
Figure 12. Improper 3-way placard (southward view).

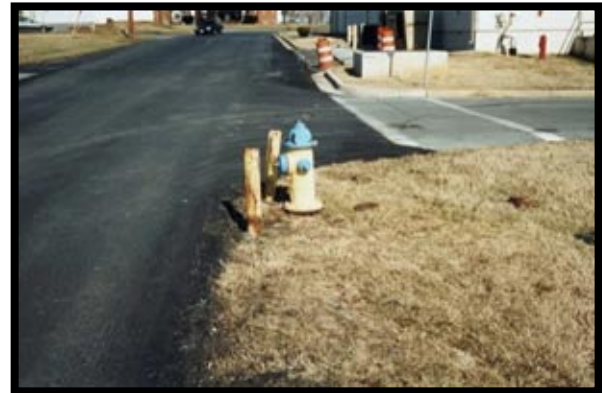
Figure 13. Fixed objects in the clear zone at the intersection of Gardner and Sultan (eastward view).

All signs that are placed in the clear zone should be of a suitable breakaway or yielding design. Objects, such as the posts shown in Figure 13 should be removed or relocated outside the clear zone, if possible. Utility poles are located within the clear zone at some locations. This situation was noted particularly along Doughten Drive, where a number of utility poles are approximately 4-foot from the edge of roadway (Figure 14).

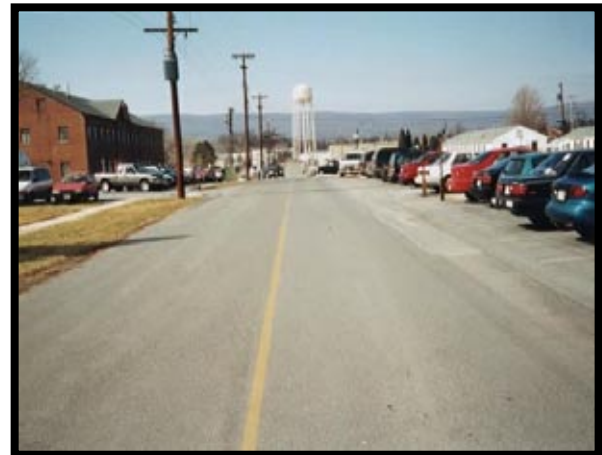
Figure 14. Utility poles in clear zone; Non-standard single, yellow center line; no edge lines; and angle on-street parking along Doughten Drive (northward view).

Many of the post roadways are marked with a single, solid, yellow center line or no center line at all. A single, solid, yellow center line is not a standard pavement marking. On two-lane, two-way roadways which are 16 feet or more in width, a center line is recommended. Improper or inadequate pavement markings are a tremendous source of liability.

- **On-street parking** – Angled on-street parking may potentially cause vehicular conflicts, as vehicles back from a parking space into the travel lane. In the future, parallel on-street parking or off-street parking should be considered (refer to Figure 14).

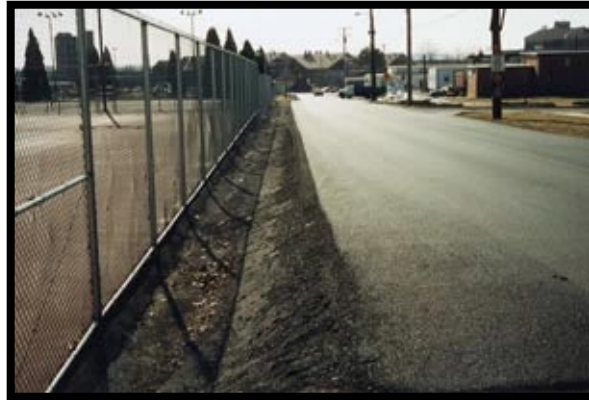
Figure 15. Ditch within clear zone along Sultan Drive (westward view).

- **Slopes** – Steep slopes present within the clear zone should be protected with guiderail. Figure 15 illustrates a steep drop off into a drainage ditch along Sultan Drive.

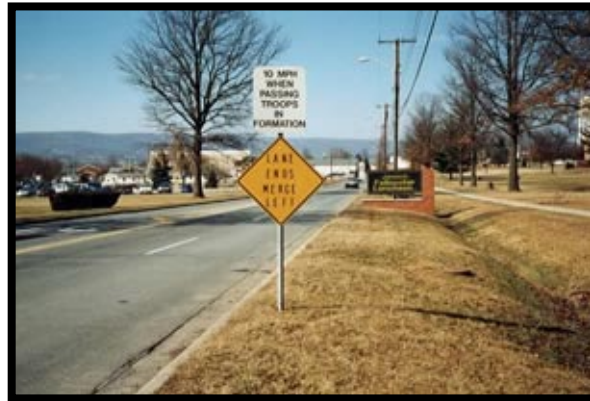
Figure 17. Unrelated, non-standard signs on the same post on Ditto Avenue (northward view).

4. Unrelated signs should not be mounted on the same sign post. For example, see Figure 17.

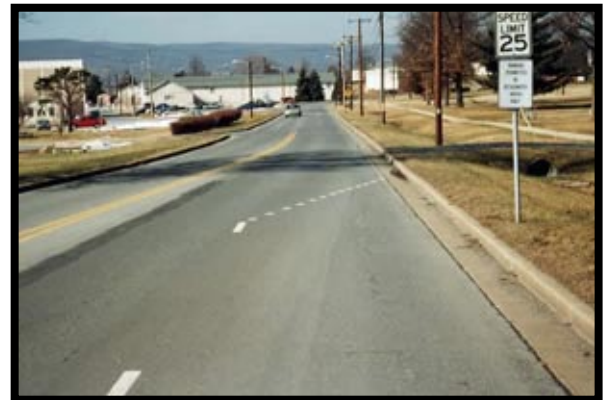
- **Lane Transitions** – An inadequate lane transition along Ditto Road, immediately north of Porter Street, is pictured in Figure 18. The transition from two lanes to one lane is only 36 feet in length. According to the MUTCD, the transition should be a minimum of 115 feet (assuming an 11-foot lane width), following the formula:

Figure 18. Lane drop transition on northbound Ditto Avenue.
